Comparison of Air Quality Monitoring enclosures

A side-by-side comparison of an ET designed roadside station alongside a competitor's station.

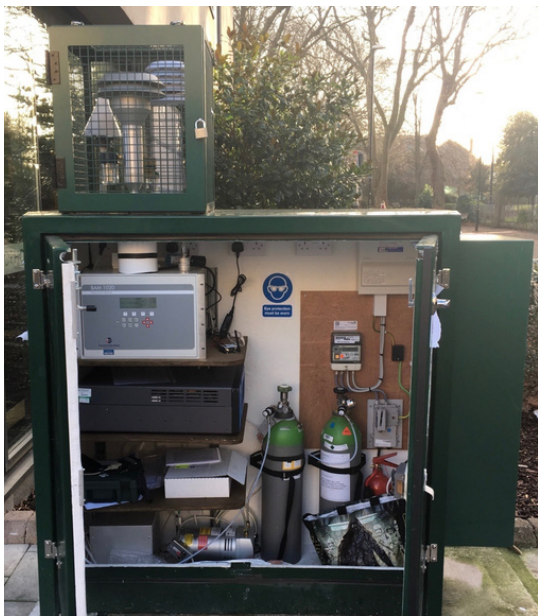
Figure 1: An ET PR5 Professional Air Quality Monitoring Station

- Professional, neat and tidy build
 - High quality fittings and fixtures
 - Professional, safe and tidy electrics and wiring
 - Optimal placement of PM10 monitor and NOx analyser

- Adequate air-conditioning unit, well positioned and ventilated
 - Easy access to all instrumentation for all users and service providers
 - Well designed and carefully planned layout

- A monitoring station that the supplier and customer can be proud of
 - GRP construction, rust-proof, designed to last
 - Defra MCERTS Approved PM10 monitor
